SUMMARY REPORT
GROUND PROJECT SURVEYS
FOR THE QUARTER ENDED
DECEMBER 31, 2005

SIGIR PA-06-048
APRIL 13, 2006

SUBJECT: Summary Assessment Report of Ground Project Surveys for the Quarter
Ended 31 December 2005 (Report Number SIGIR-PA-06-048)

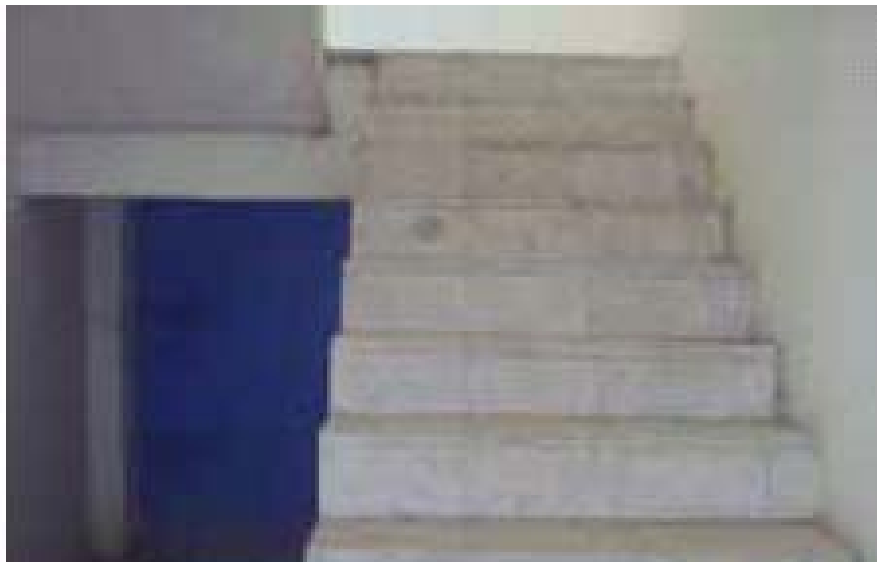
- The interior stairwell was missing handrails (Site Photo 2).
- Cracks were in some interior walls and the external corner tower.

Site Photo 2: Interior stairwell without handrails at Project 12144

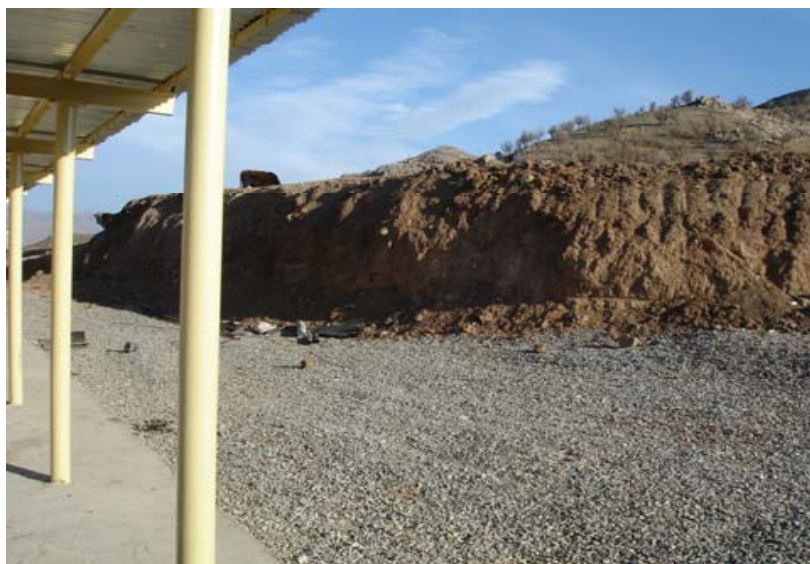
- No perimeter security fences or gates were present.
- Leaking roof drains are causing problems with the plaster, both inside and outside the building. In addition, the roof structures over the parking and generator areas contained loose bolts and possible weak welds.
- A ridge formed by site leveling lacked stabilization. Site Photo 4 shows the cut bank without stabilization.
- The border patrol guards indicated that they received minimal training on the use of the generators. Technical manuals, spare parts, and maintenance schedules were not available.
- There is a septic system present, however, the quality of the concrete used for the tank is poor, possibly due to improper mixture or curing procedure. In addition, border patrol guards indicated no provisions exist to support this post with water.

Site Photo 4: Cut bank with no stabilization Project 12787

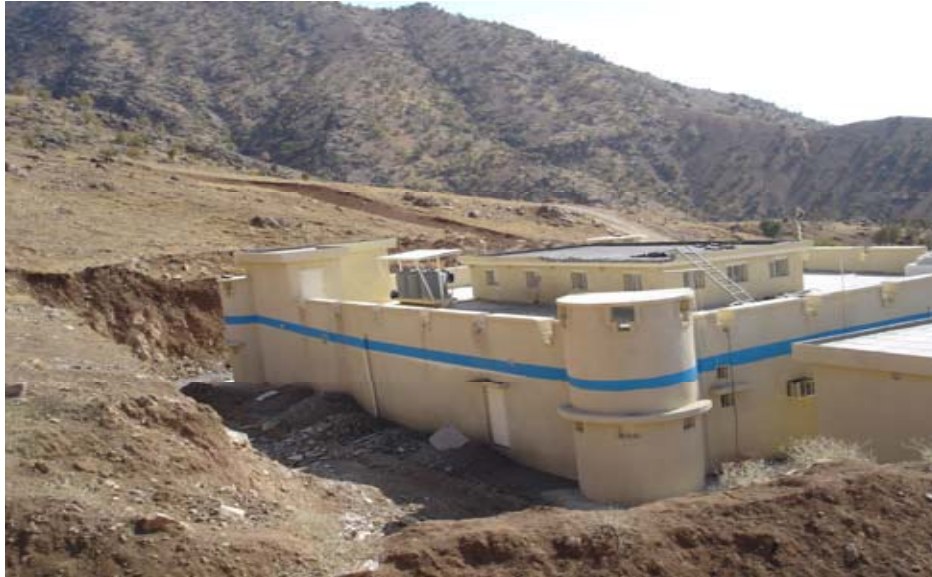
- No perimeter security fences or gates were present.
- A slope, created by site leveling, and appearing to be composed of loose material, lacked retaining walls or soil reinforcement. Site Photo 5 shows the cut bank without stabilization.
- Water tank pump switches have un-insulated wires, exposing them to the environment, which may pose a hazard to personnel in the area. In addition, water pipes lacked proper insulation for winter conditions.

Site Photo 5: Cut bank with no stabilization Project 12800

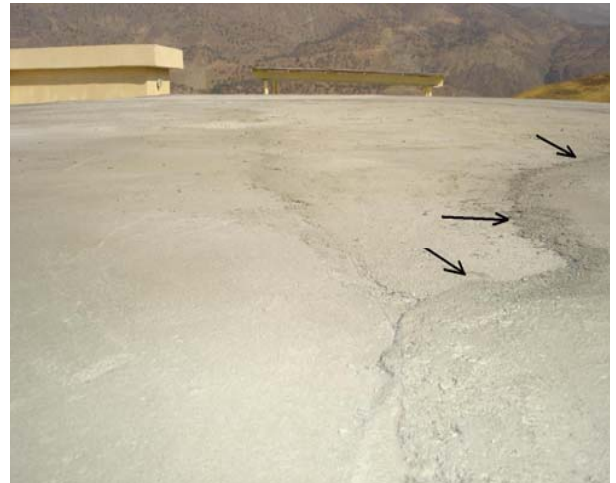
- No perimeter security fences or gates were present. Site Photo 6 shows the front view of project 12840.
- Concrete on the atrium roof showed inconsistent textures, possibly the result of non-continuous pour. Site Photo 7 shows the atrium concrete roof.
- Spot welds on the generator roofing appeared to be poor quality.

Site Photo 7: Concrete atrium roof showing uneven texture at Project 12840

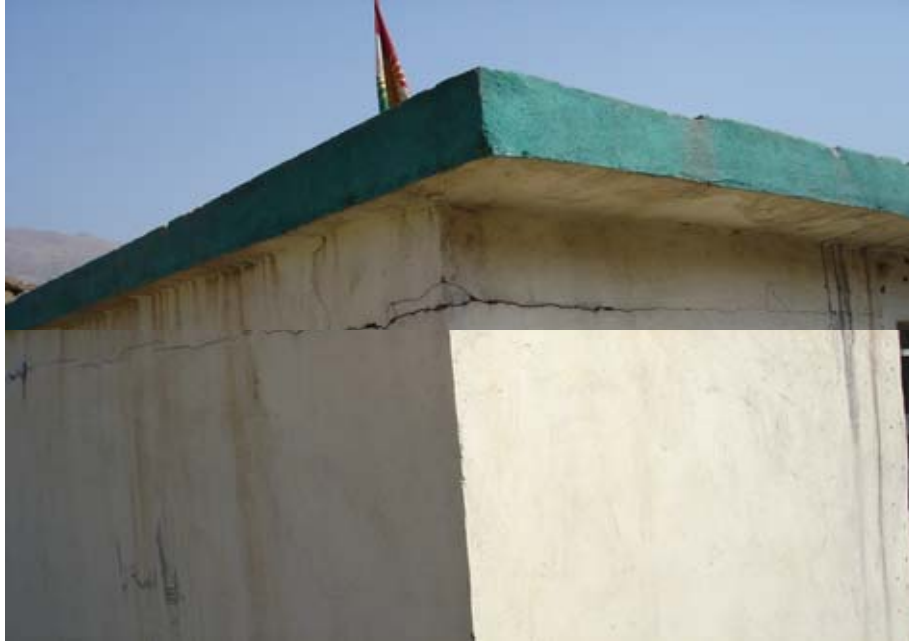
- The site lacked a generator.
- The facility lacked security fences.
- Concrete segregation and re-bar exposure was visible on interior concrete slab ceilings.
- Interior walls showed staining, probably due to water leaking from the ceiling area.
- Extensive cracking was visible on the exterior walls of the building (Site Photo 8).
- The facility showed lack of any recent maintenance or remodeling.

Site Photo 8: Cracks in exterior wall at Project 20565

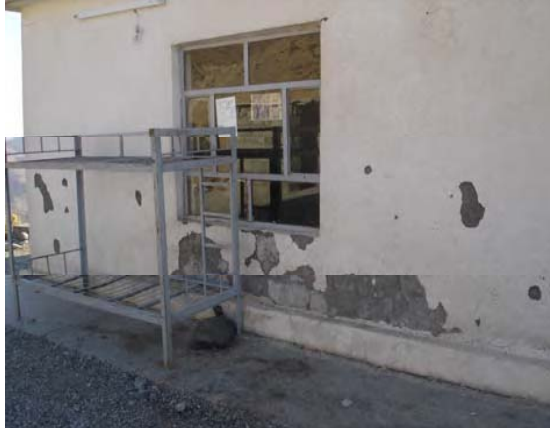
- Although a small generator was on site, fuel storage was not available.
- The plastering of external walls and sidewalks contained cracks and fractures. Site Photo 9 shows the exterior of a building with missing plaster.
- Most of the lights were broken and electrical wires were un-insulated.
- Bathroom fixtures appeared to be inoperative (Site Photo 10).
- The facility lacked security fences.
- The facility showed a lack of any recent maintenance or remodeling.

Site Photo 9: Exterior wall at project at Project 20568

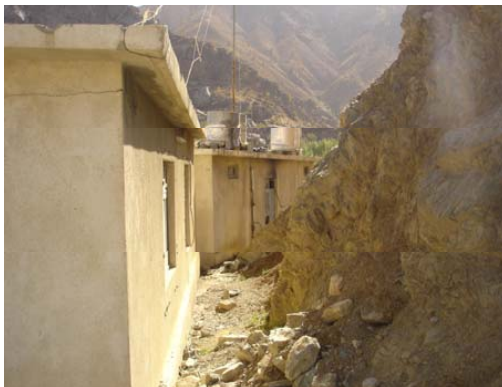
- A slope, created by site leveling, and appearing to be composed of loose material, lacked retaining walls or soil reinforcement. Site Photo 11 shows the cut bank located behind the border post.
- There was no security fence or security lighting, and only one window contained security bars. In addition, the doors appeared to be missing or in need of replacement.
- There were cracks in the building foundation and walls, and one set of stairs was crumbling. In addition, the finish work was in poor condition. Site Photo 12 shows the concrete steps.
- A small generator was on site; however, fuel storage was not available.
- The bathroom was missing some fixtures, and the water and sewer pipes were in need of repair or replacement.
- The facility showed a lack of any recent maintenance or remodeling.

Site Photo 11: Behind border post at Project 20569

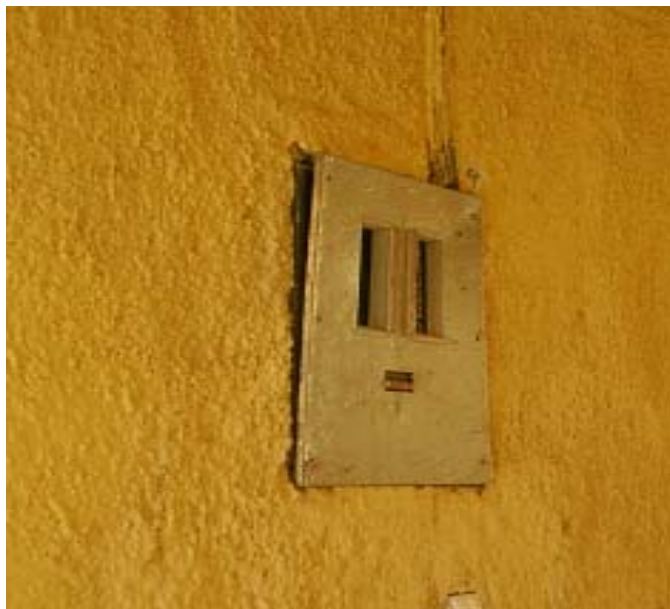
- Interior and exterior wall finish appeared new, however, it was questionable whether repairs were made or walls were just painted over.
- Doors were old and needed replacement. There were no sidewalks.
- Installation of the electrical breaker box was poor. Site Photo 13 shows the electrical circuit breaker panel at Project 10588.

Site Photo 13: Electrical circuit breaker panel at Project 10588

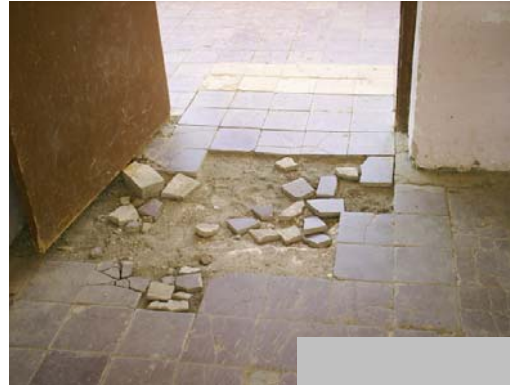
- Paint, woodwork, doors, and floors were not consistent with new construction or recent remodeling. For example, the wall finish was of poor quality, portions of classrooms lacked any tile or floor material, and tiles and grout were missing from other floors. Site Photo 16 shows damaged tile in one of the classrooms.

Site Photo 16: Broken tiles at Project 10630

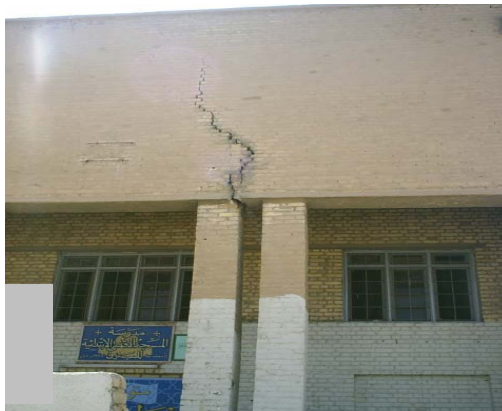
- The concrete pad outside the building lacked sub-base and proper compacting.
- Parts of the school structure showed significant cracking above columns and the perimeter wall was crumbling in some areas. Site Photo 17 shows the cracking above columns.

Site Photo 17: Crack in outer wall of Project 10630

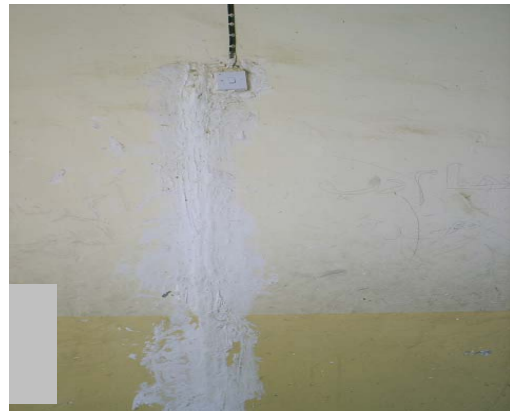
- The main electrical switch was inaccessible and patching on the wall indicated completion of electrical work after finish work completion. Site Photo 18 shows electrical work and patching.

Site Photo 18: Patching of wall at Project 10630

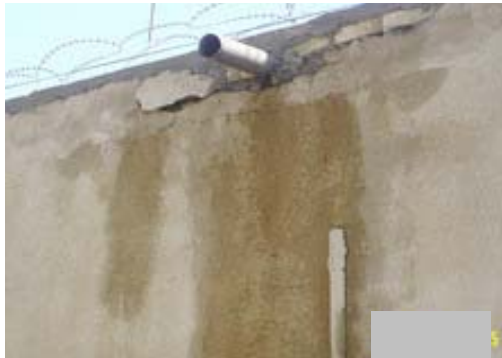
Site Photo 26: Exterior roof drain and deteriorated parapet at Project 18223

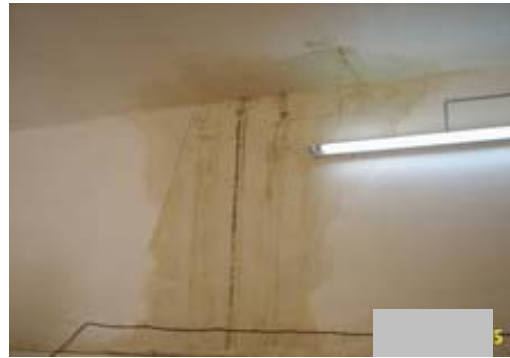
Site Photo 27: Interior staining due to roof leak at Project 18223

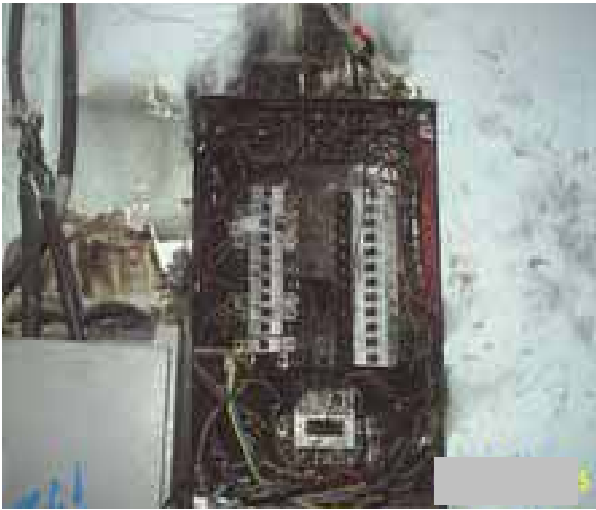
- Light fixtures were not properly mounted and they hung from electrical wires. The electrical circuit box showed poorly installed wiring as seen by partially un-insulated splices. The wall around the electrical circuit box showed signs of burn marks, indicating previous shortages and/or small fires. Site Photo 28 shows the electrical circuit breaker panel.
- No sidewalks were located at the facility.
- There were cracks in the walls and areas with peeling paint. There were unfinished surfaces on walls near the front of the facility. Site Photo 29 shows an unfinished wall section.
- Work did not appear consistent with contract requirements.

Site Photo 28: Electrical circuit breaker panel at Project 18223

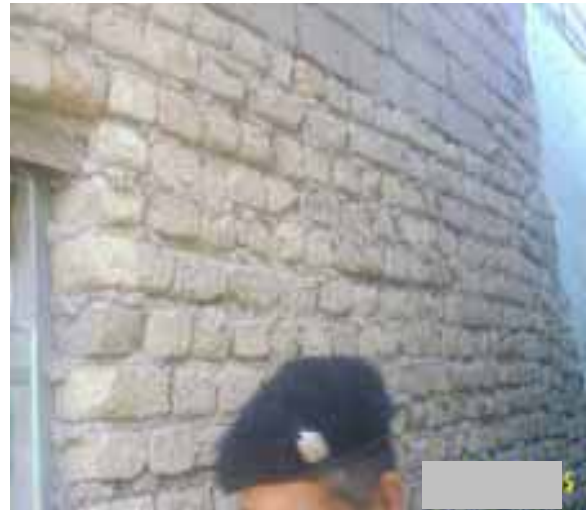
Site Photo 29: Unfinished exterior wall at Project 18223

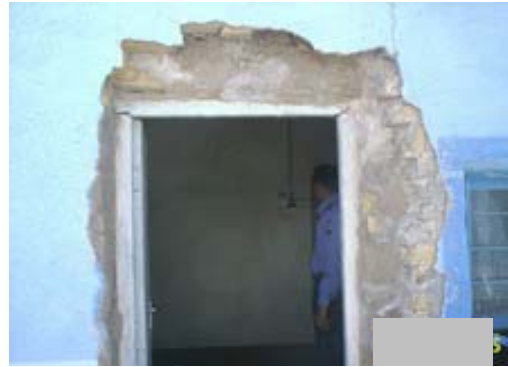
- The exterior perimeter wall did not have plaster finishing or paint.
- The exterior doorway had incomplete finishing work. Site Photo 33 shows the exterior doorway requiring finishing work.

Site Photo 33: Exterior doorway with incomplete finishing work at Project 18248

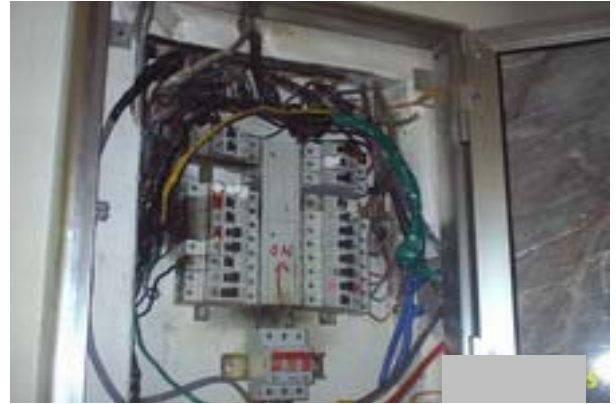
- The exterior and interior walls contained cracks.
- The electrical circuit breaker panel appeared disorganized and was discolored, possibly due to an electrical fire (Site Photo 35).

Site Photo 35: Electrical circuit breaker panel at Project 18268

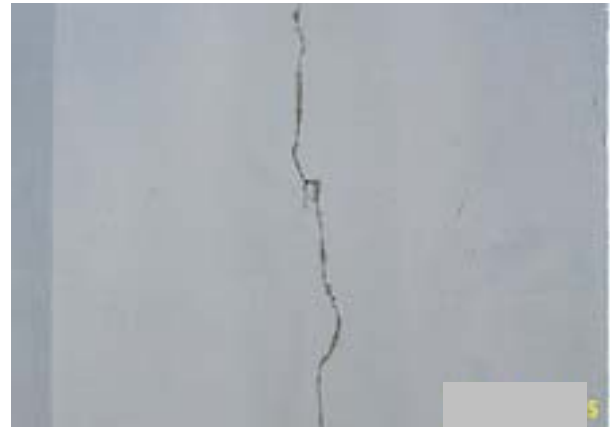
- The contract required the repair of the interior and exterior walls however, the exterior and interior walls contained numerous cracks (Site Photo 37).
- Exterior tiles showed signs of deterioration, indicating the tiles were not replaced.

Site Photo 37: Cracks in exterior wall at Project 18273

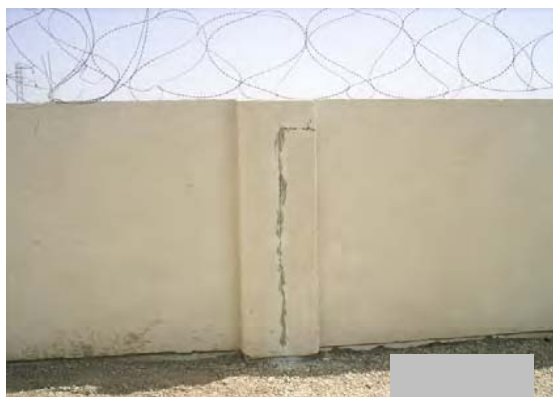
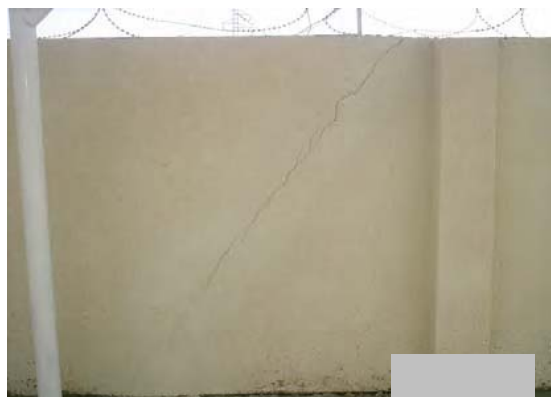
- Numerous cracks were visible in the perimeter wall. Site Photos 38 and 39 show cracks in the perimeter security walls.
- The finishing paint on the checkpoint structures appeared to be incomplete.

Site Photo 38: Cracks in perimeter security wall at Project 19217

Site Photo 39: Cracks in perimeter security wall at Project 19217

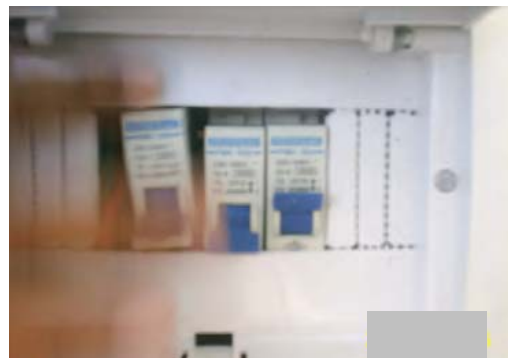
- Lack of conduit for electrical wiring that was routed outside the building.
- Improper installation of circuit breakers and missing electrical outlets at switch locations. Site Photo 43 shows the circuit breaker panel at Project 19220.
- A door was inoperable and a ceiling area appeared unfinished.

Site Photo 43: Circuit breakers at Project 19220

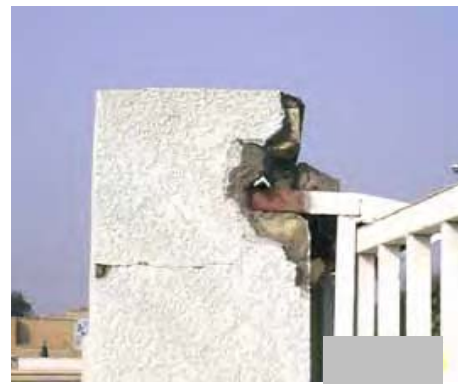
- The sidewalk showed numerous cracks.
- Covers were missing on electrical components.
- A portion of the external wall appeared damaged. Site Photo 47 shows exterior wall damage.

Site Photo 47: Wall damage at Project 19222

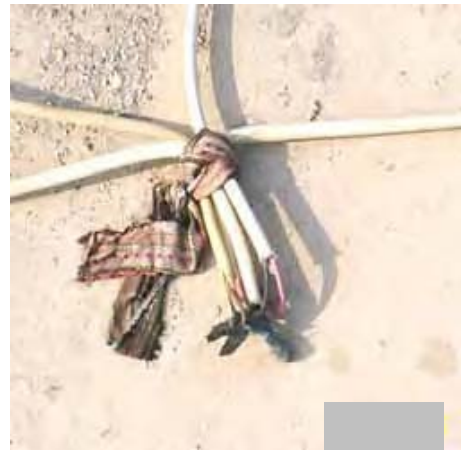
- Roof repair was not a line item in the contract, although the roof was in need of renovation.
- The main building showed no apparent sign of recent painting, although the contract stated, “paint entire exterior of building with 3 coats of good quality exterior enamel paint.”
- Electrical work was of poor quality as evidenced by several wires lacking conduit, and improperly completed electrical connections. Site Photo 49 shows an example of electrical connections at Project 19223.

Site Photo 49: Electrical wires without proper connections at Project 19223

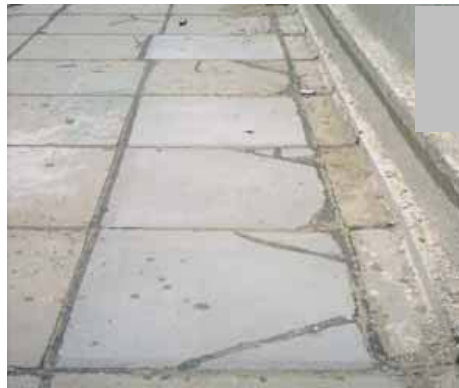
- Improper cementing of floor tiles, as well as several broken floor tiles.
- Roof work consisted of reused broken roof tiles, which might account for an interior room showing signs of water damage. Site Photo 50 shows broken tiles.
- Plaster covered electrical switch surfaces. Site Photo 51 shows electrical switches covered with plaster.
- Electrical, plumbing, and finishing work was of poor quality throughout the building.

Site Photo 50: Broken roof tiles at Project 20333

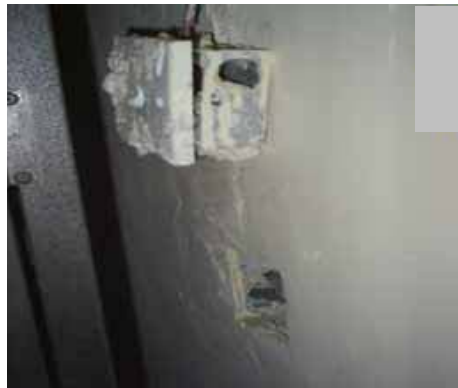
Site Photo 51: Light switch with plaster over surface at Project 20333

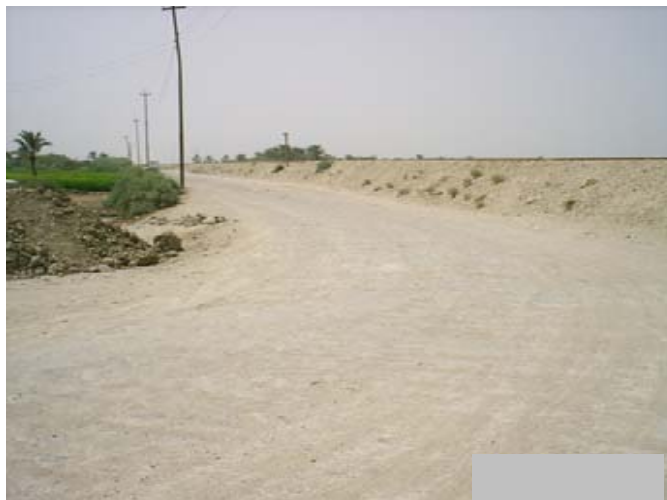
Although the IRMS database listed the project as 100 percent complete, the site visited by the survey team was not a completed road. The site visited was within 725 m from the reported location and intersected the location of the road as shown in the contract. The site visited consisted of 3.5 km of road, with recent sub base installed and no culverts or shoulders. No section of road contained any asphalt pavement. Site Photo 55 shows new road base at the location of Project 17867.

Site Photo 55: Road surface at the location of Project 17867
